MODEL BD-700-1A10 (BD-700)

ATA 71-23, 71-24

SPECIAL CHECK – FRONT AND REAR ENGINE MOUNT ASSEMBLIES – INSPECTION OF BUSHINGS ON THE ENGINE MOUNT SYSTEM

Global 6500

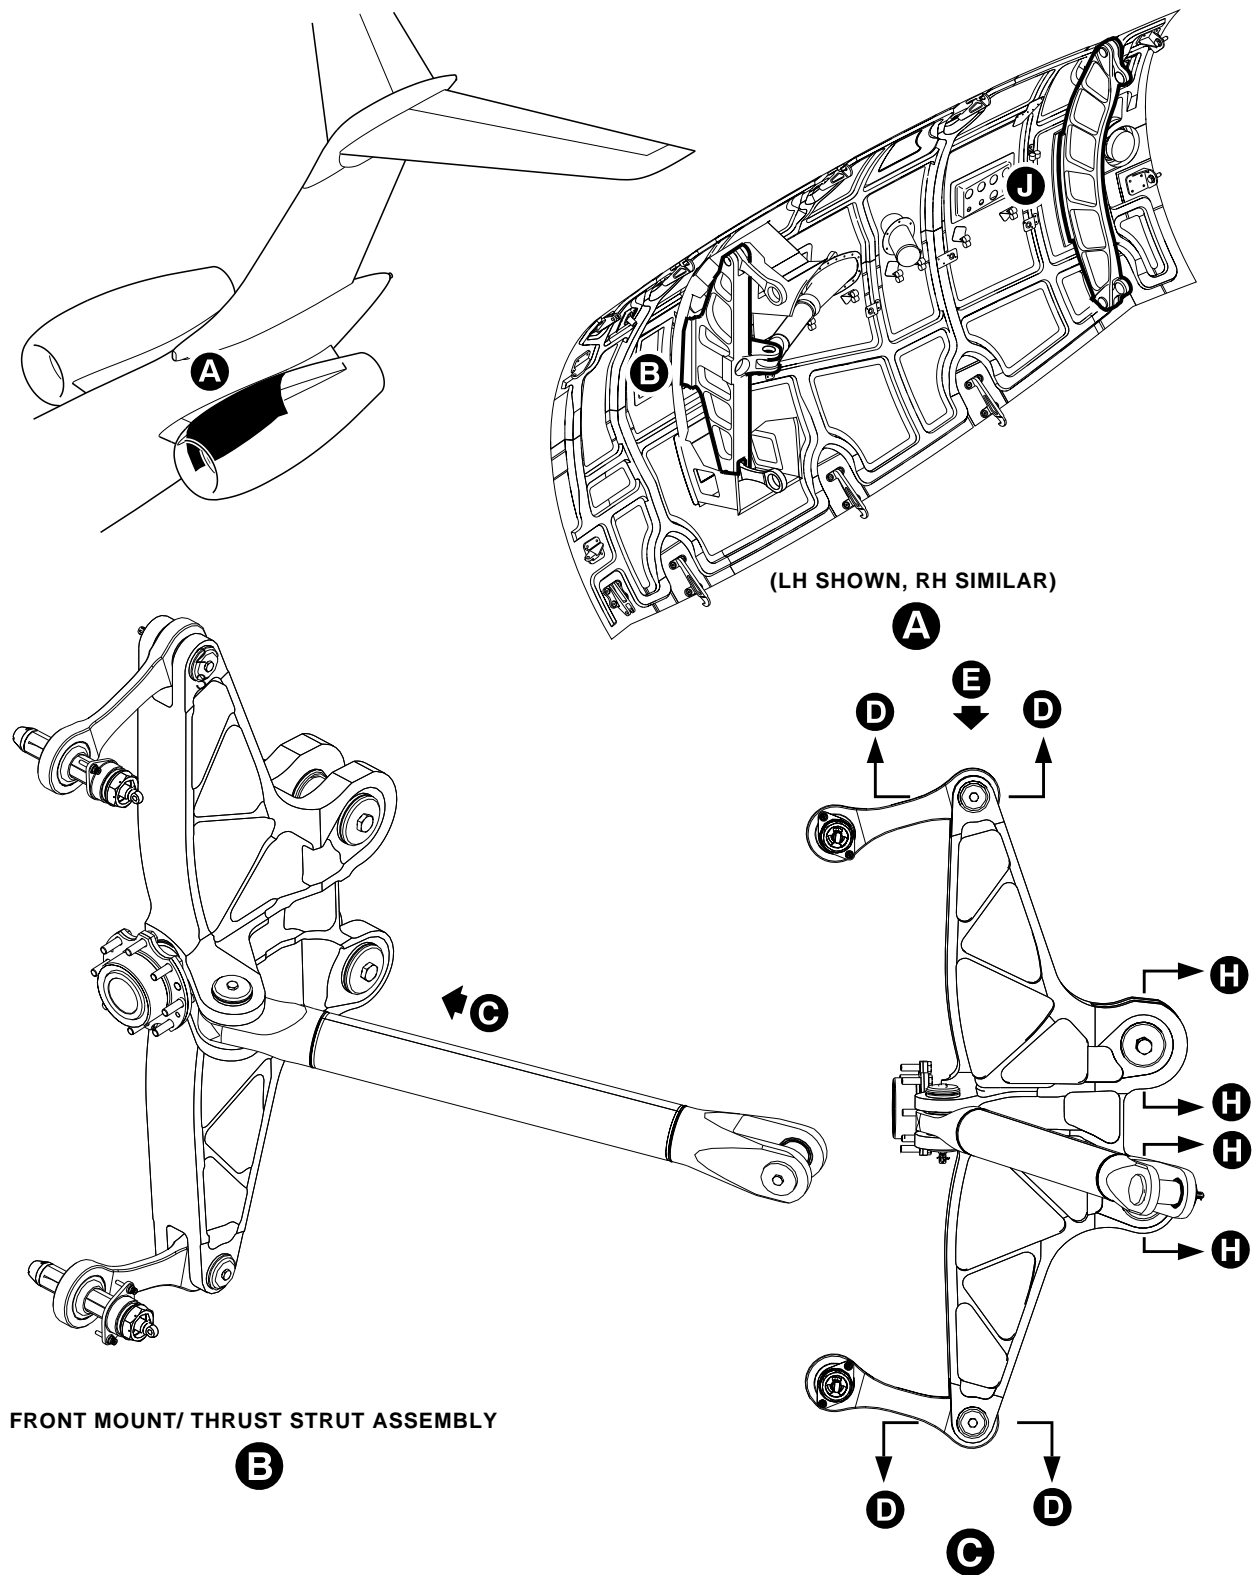
Inspection of Sliding Bushings
Figure 1 (Sheet 1 of 6)

There have been reports that bushings were missing from the forward engine mount system.

This Service Bulletin instructs to inspect the forward and aft engine mount system for missing bushings and to verify the proper installation of the sliding bushings. Continued operation of engine with bushings missing will result in redistribution of load/stress in the engine mount system and may lead to the damage of mount components.

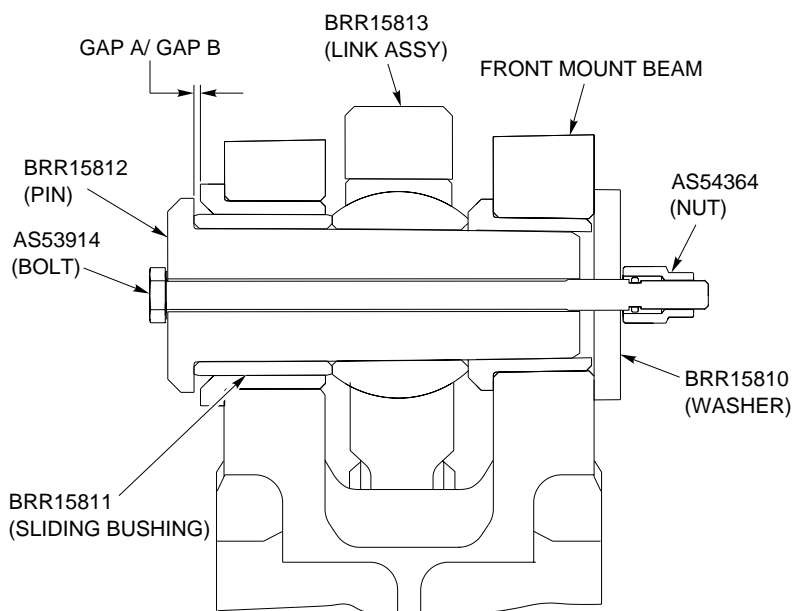
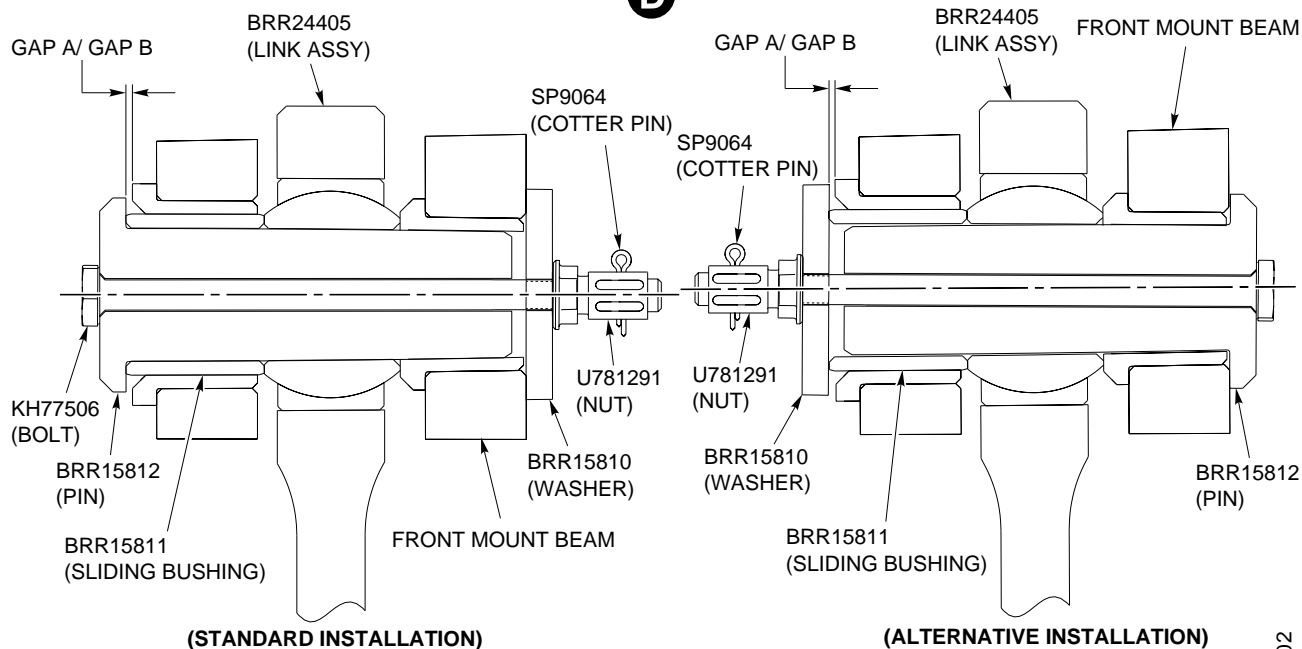
- (a) Using a feeler gauge, measure Gap A between front mount beam pin, Part No. BRR15812 and the shouldered bushing installed on the front mount beam (standard installation), or gap between the shouldered bushing installed on the front mount beam and the washer Part No. BRR15810 (alternative installation), must be between 0.004 and 0.055 in (0.10 and 1.40 mm).

- (a) Using a feeler gauge, measure Gap B between front mount beam pin, Part No. BRR15812 and the shouldered bushing installed on the front mount beam (standard installation), or gap between the shouldered bushing installed on the front mount beam and the washer Part No. BRR15810 (alternative installation), must be between 0.004 and 0.055 in (0.10 and 1.40 mm).

NOTE: If the gap is not within acceptable limits, fill out an SRPSA and send it by E-mail at:

- (b) For Pre SB BR700-71-101976 aircraft, inspect the nut, Part No. AS54364 and bolt, Part No. AS53914 at the upper side of front mount beam for missing or physical damage.

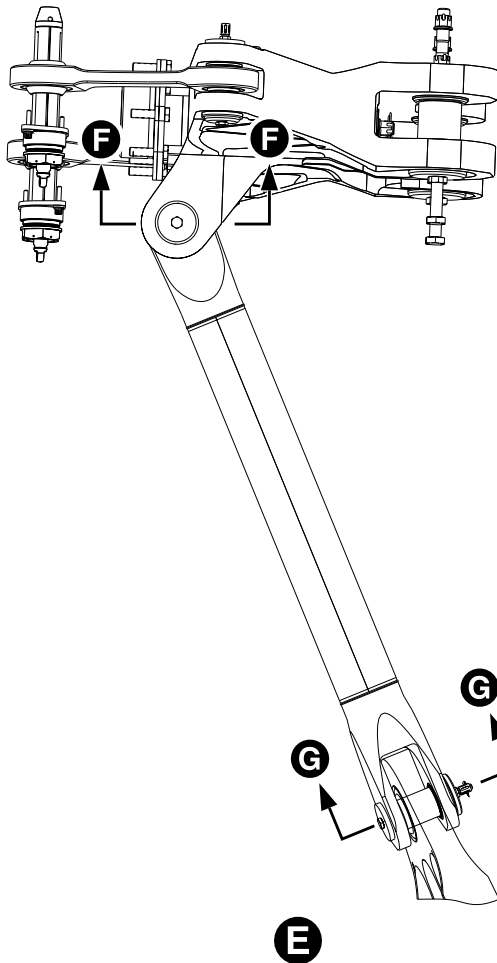
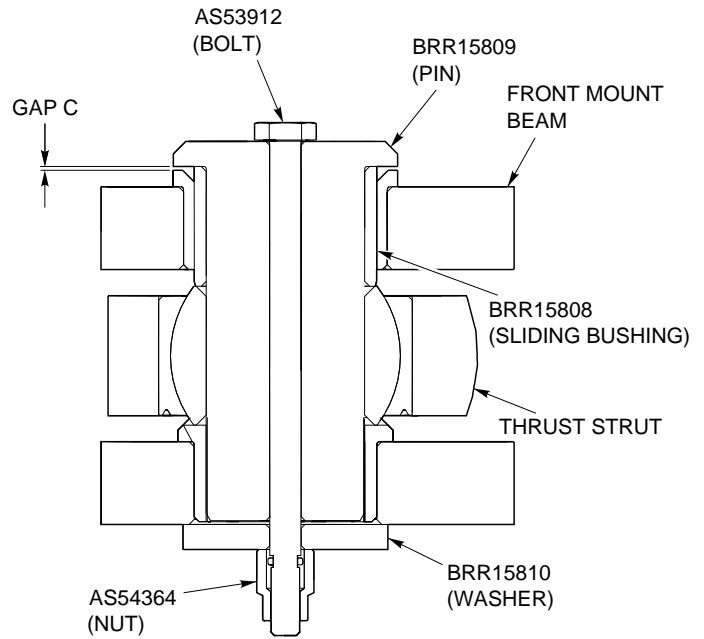
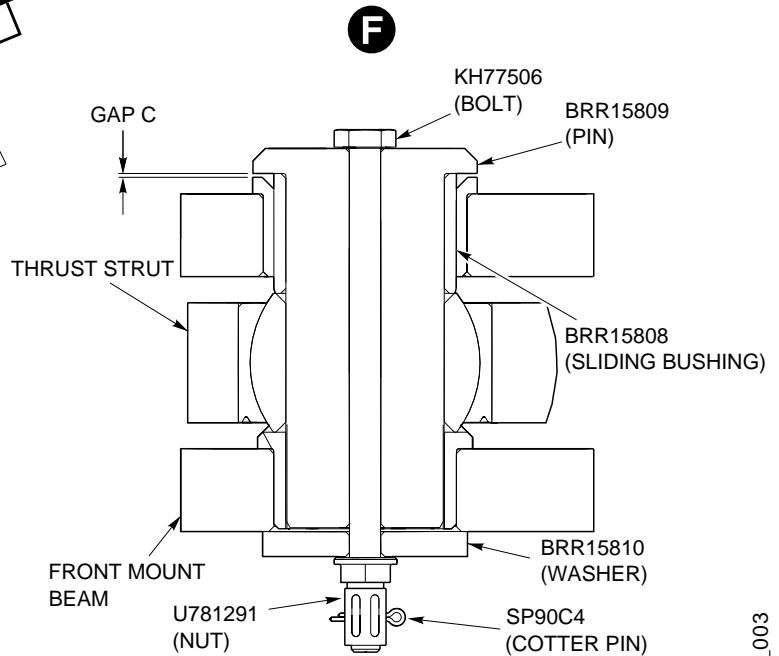
- (a) Using a feeler gauge, measure Gap C between the front mount beam pin, Part No. BRR15809 and the shouldered bushing installed on the front mount beam, must be between 0.008 and 0.050 in (0.20 and 1.30 mm).

GAP	Range of the gap to be measured
C	Between 0.008 in. and 0.050 in. (0,20 mm and 1,30 mm)

NOTE: If the gap is not within acceptable limits, fill out an SRPSA and send it by E-mail at:

- (b) For Pre SB BR700-71-101976 aircraft, inspect the nut, Part No. AS54364 and bolt, Part No. AS53912 at the thrust strut front location for missing or physical damage.

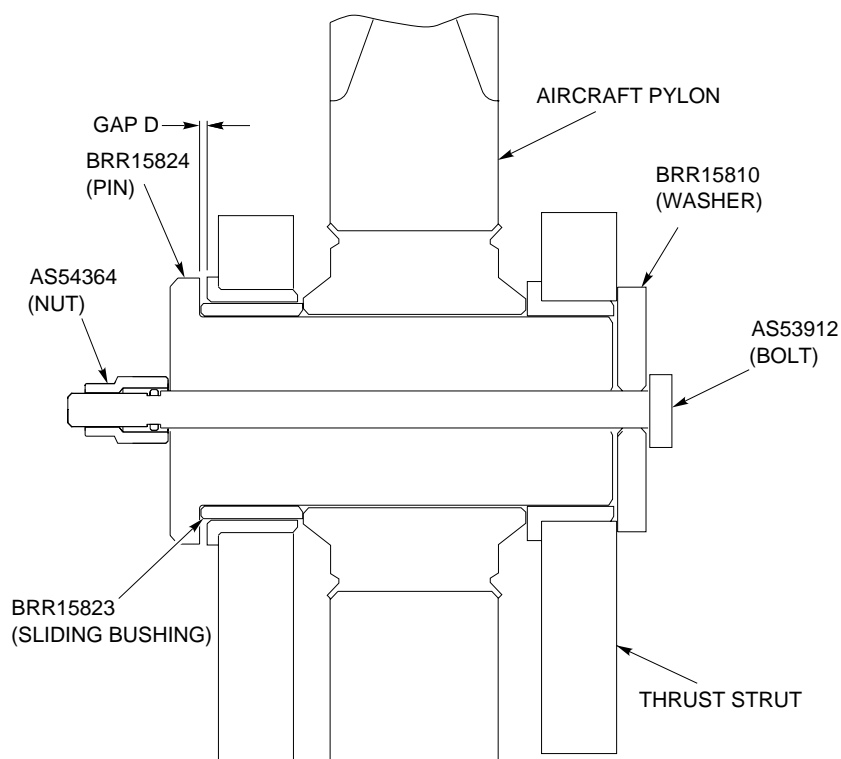
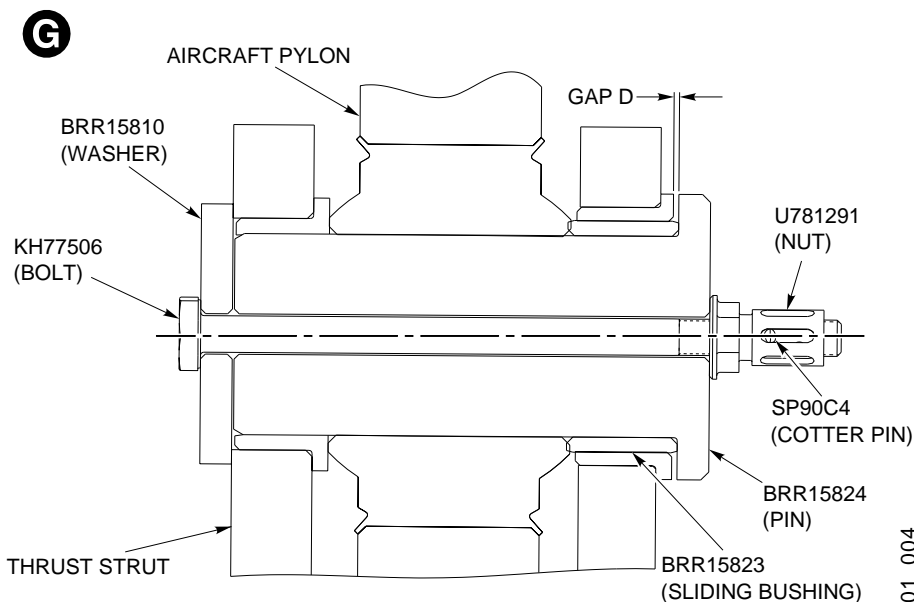
- (a) Using a feeler gauge, measure the Gap D between the thrust strut pin, Part No. BRR15824 and the shouldered bushing installed on the thrust strut, must be between 0.008 and 0.055 in (0.20 and 1.40 mm).

GAP	Range of the gap to be measured
D	Between 0.008 in. and 0.055 in. (0,20 mm and 1,40 mm)

NOTE: If the gap is not within acceptable limits, fill out an SRPSA and send it by E-mail at:

- (b) For Pre SB BR700-71-101976 aircraft, inspect the nut, Part No. AS54364 and bolt, Part No. AS53912 at the thrust strut aircraft pylon interface for missing or physical damage.

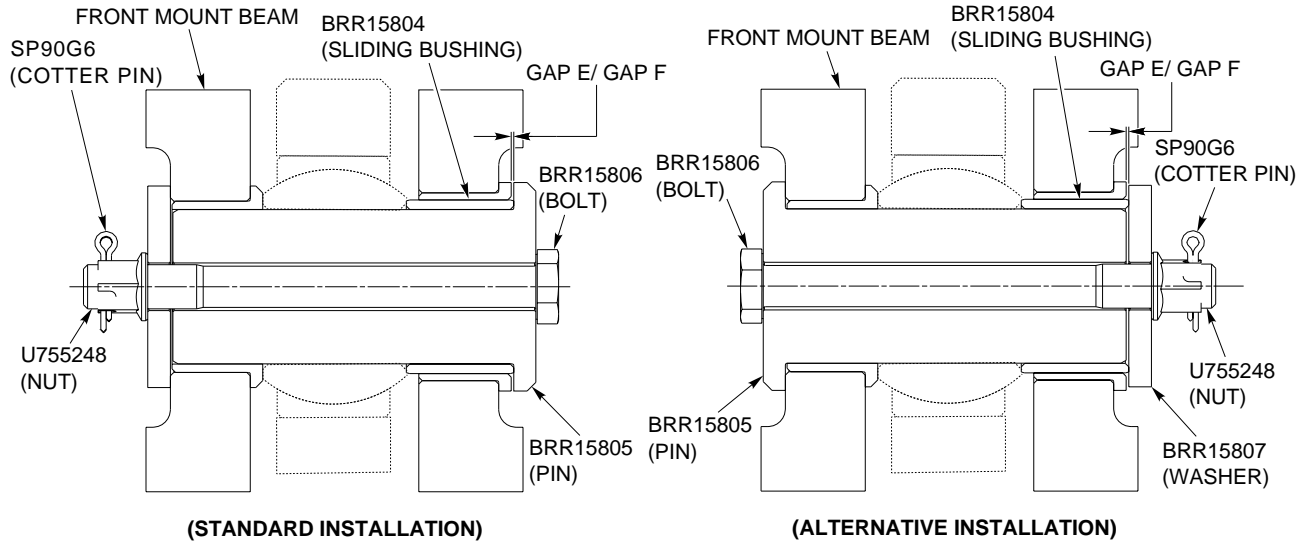
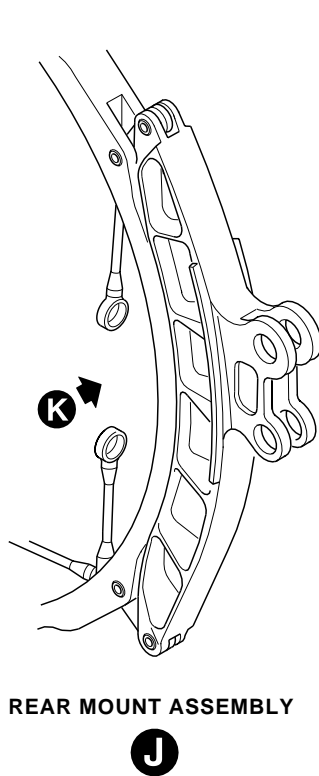
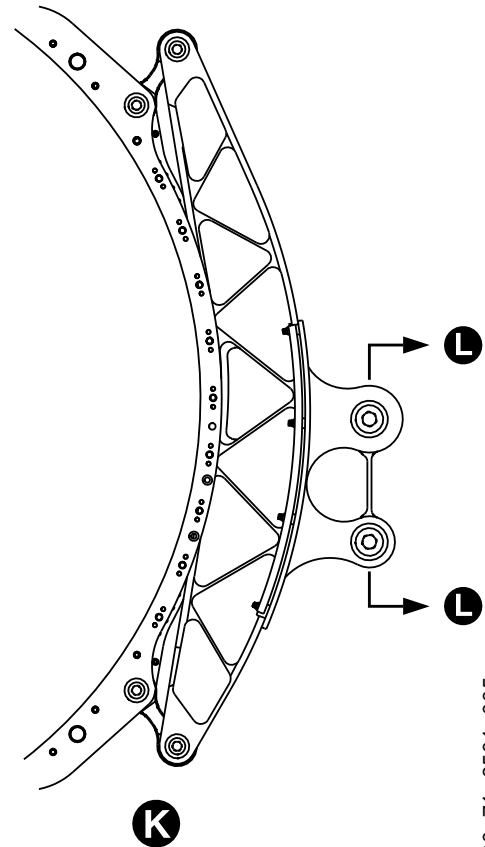
Inspection of Sliding Bushings
Figure 1 (Sheet 5 of 6)

- (a) Using a feeler gauge, measure Gap E between the front mount beam pin, Part No. BRR15805 and the shouldered bushing installed on the front mount beam (standard installation) or gap between the washer Part No. BRR15807 and the shouldered bushing installed on the front mount beam (alternative installation), must be in between 0.008 and 0.048 in (0.20 and 1.20 mm).

- (a) Using a feeler gauge, measure Gap F between the front mount beam pin, Part No. BRR15805 and the shouldered bushing installed on the front mount beam (standard installation) or gap between the washer Part No. BRR15807 and the shouldered bushing installed on the front mount beam (alternative installation), must be in between 0.008 and 0.048 in (0.20 and 1.20 mm).

GAP	Range of the gap to be measured
E	Between 0.008 in. and 0.048 in. (0,20 mm and 1,20 mm)
F	Between 0.008 in. and 0.048 in. (0,20 mm and 1,20 mm)

NOTE: If the gap is not within acceptable limits, fill out an SRPSA and send it by E-mail at:

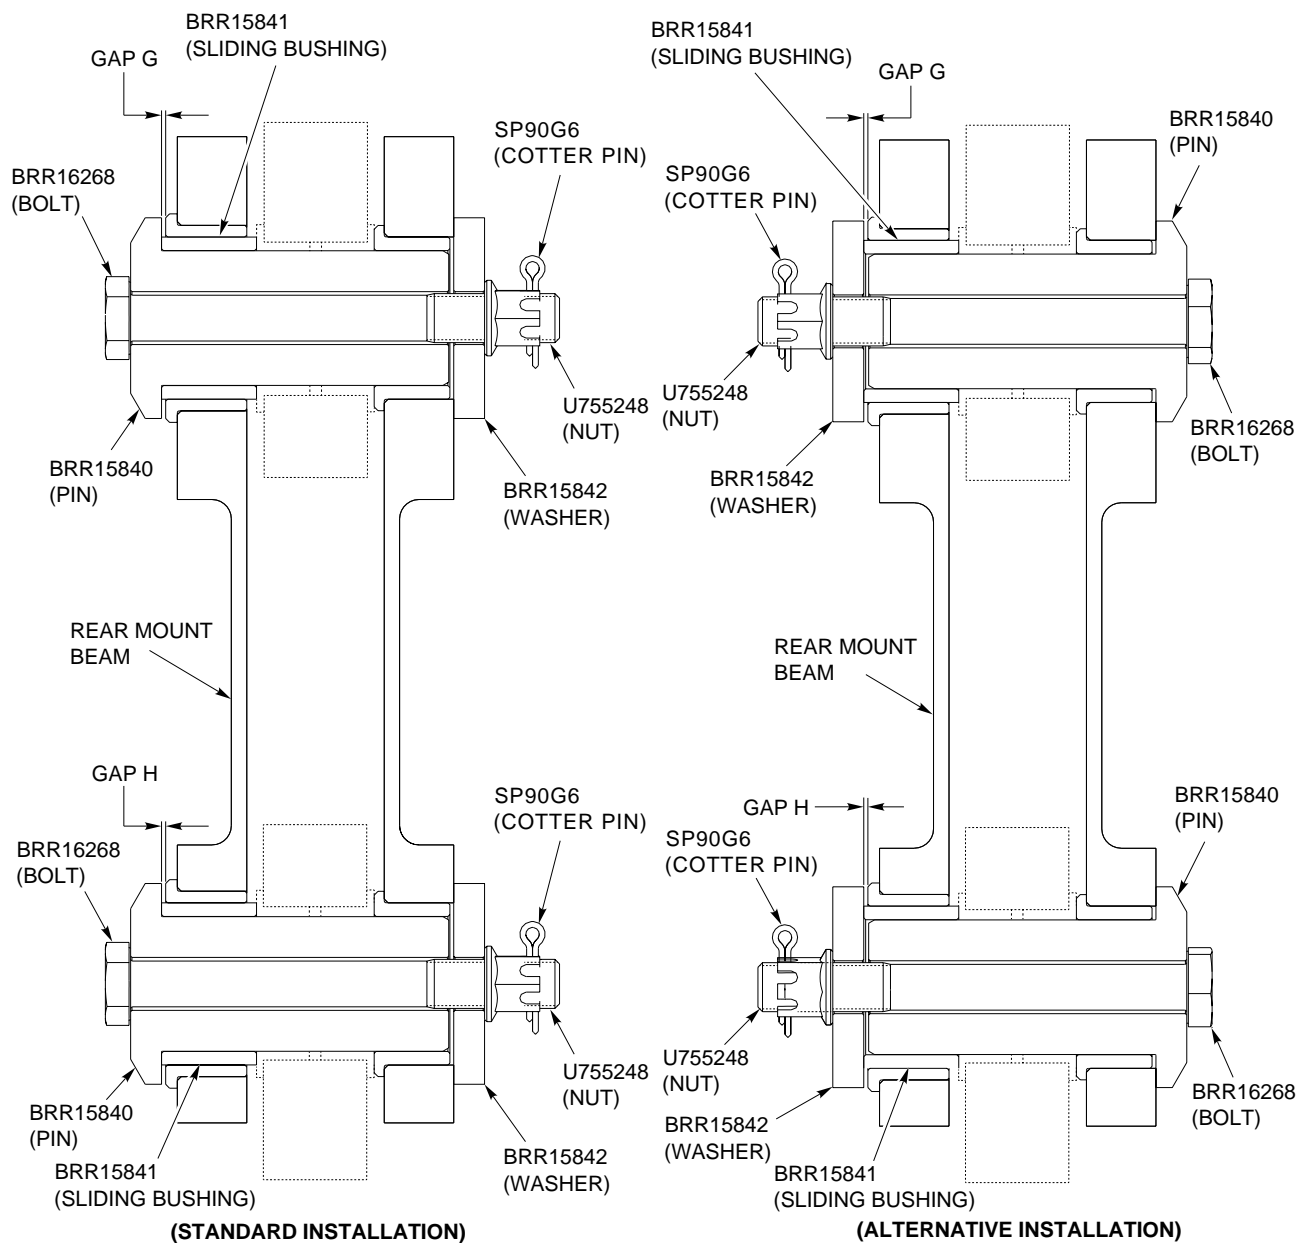
- (a) Using a feeler gauge, measure Gap G between the rear mount beam pin, Part No. BRR15840 and the shouldered bushing installed on the rear mount beam (standard installation) or gap between the washer Part No. BRR15842 and the shouldered bushing installed on the rear mount beam (alternative installation), must be between 0.004 and 0.071 in (0.10 and 1.80 mm).

- (a) Using a feeler gauge, measure Gap H between the rear mount beam pin, Part No. BRR15840 and the shouldered bushing installed on the rear mount beam (standard installation) or gap between the washer Part No. BRR15842 and the shouldered bushing installed on the rear mount beam (alternative installation), must be between 0.004 and 0.071 in (0.10 and 1.80 mm).

NOTE: If the gap is not within acceptable limits, fill out an SRPSA and send it by E-mail at:
